## CASE STUDY

# Shutting Down Plumbing Leaks in Commercial Mechanical Rooms

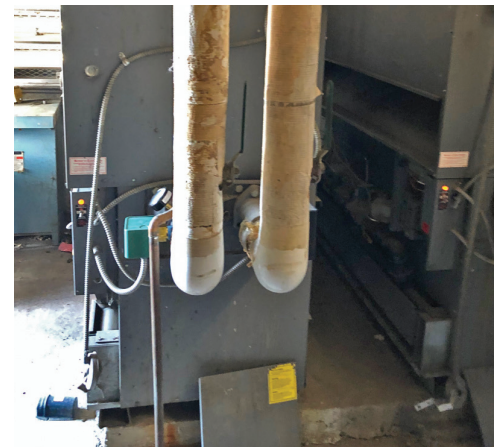
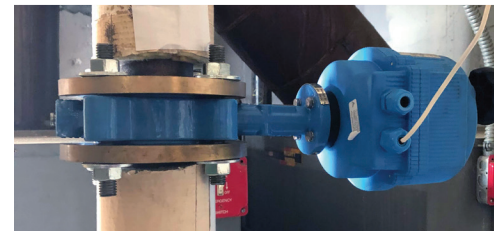
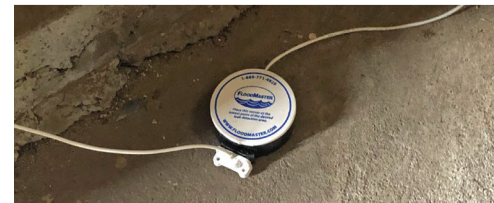
***Oversized automatic shut-off valve sizes and plenum-rated electrical components make the RS-080-MK6 an ideal solution for many commercial leak detection applications. Wired sensors were integrated with RSC-900 wireless system technology to provide real-time system status notifications via RDT's free smartphone app.***

RDT designed a wide-area system to monitor the building's mechanical rooms, containing domestic/potable hot water heaters and heating system boilers. A trio of FloodMaster® **RS-080-MK6** kits with 2" and oversized 2-1/2" shut-off valves and plenum-rated electrical components cover three key feed points. An additional pair of RS-096-MK6 alarm boxes and a total of 11 wired sensors were deployed to cover an approx. 750 square-foot area spanning the building's two upper floors.

When a leak is detected, the three valves automatically shut off the water supply. Integrated **RSC-900-W** wireless technology provides immediate smartphone app-based system notification and allows staff to quickly pinpoint the location of any leaks.
